TEST REPORT

Ind. Ser. No. : 15-03-NEF-029
 Applicant : Penton Communications Inc.
 Address : No28-2 Ya-Tan Road, Ta-Ya, Taichung, Taiwan, R.O.C.
 Products : Bi-Slanting Metal Projector Loudspeakers
 Model : CELL10BT/EN(C) ; CELL 10/BST(C)
 Quantity : 2sets
 Date of Receipt : 2015 / 3 / 9
 Date of Testing : 2015 / 3 / 10 ~ 2015 / 3 / 11
 Test specification : IEC60529 Edition 2.1 2001-02
 Inspection Site : Electronics Testing Center, Taiwan – Southern Taiwan
 Industry Service Department
 (TAF Certification No:1161)
 Ambient Environment : IP5X Temp. 22 ± 1 °C , R.H. 42 ± 2 %
 : IPX5 Temp. 22 ± 1 °C , R.H. 43 ± 2 %
 Testing Item : IP55
 Test condition : See the following sheets&INSTALLATION GUIDE
 Test result : PASS

Testing Item: IP55

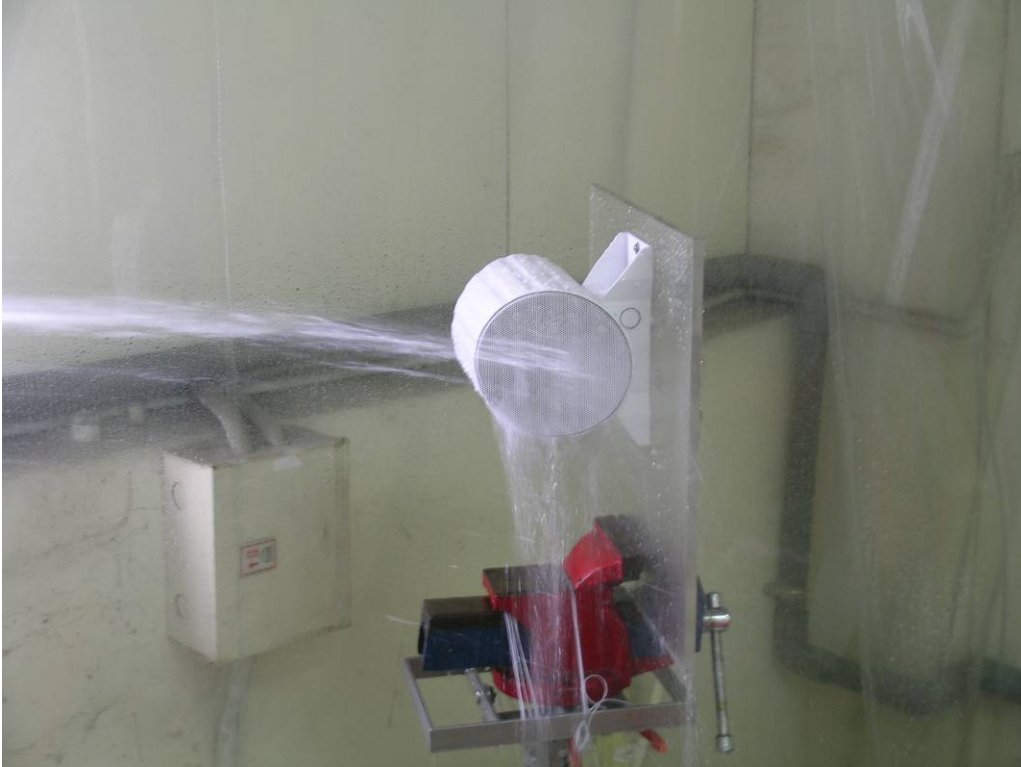
IPX5 Test

Request/Experiment	Results	Remark
Accordance with IEC60529 13.1,13.4and 13.5 test. The protection is satisfactory if no deposit of dust is observable inside the enclosure at the end of the test.	There is no trace of dust inside.	IP5X
After testing in accordance with appropriate requirements of IEC60529 14.1,14.2.5 and 14.3	No ingress of water was found inside.	IPX5
